## MENSURAL CHARACTERISTICS OF SOVIET NUCLEAR SUBMARINES

Continuing exploitation of Kii-7 photography reveals that the imagery available by the end of 1964 permits drafting of relatively detailed plan views and mensural characteristic determination of all currently identified Soviet nuclear submarines.

The report is designed to expand the knowledge available on 6 Soviet nuclear submarines, 5 of which have previously been reported in some detail. The sixth, an E-type, is apparently similar to the E-1-class SSGN but is longer than any known E-1-class SSGN. Also of significance is the confirmation of 2 types of N-class submarines, the N-II-class being approximately 20 feet longer than the N-1-class.

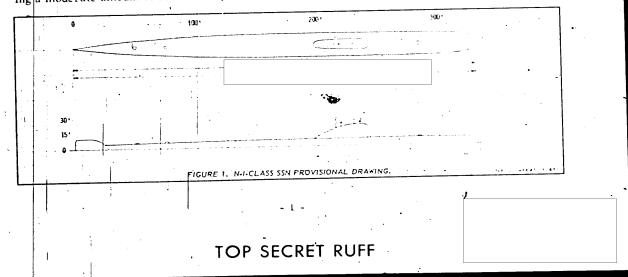
Four N-I-class SSN (Figure 1) were imaged on excellent quality photography. Two of the 4 vessels were fairly well defined and the values obtained were relatively uniform. The level of light at the time of photography was less than optimum, but the orientation of the submarines to the light was such that consistent measurements were obtained.
